Pinnacle update

November 2023

Pinnacle problems

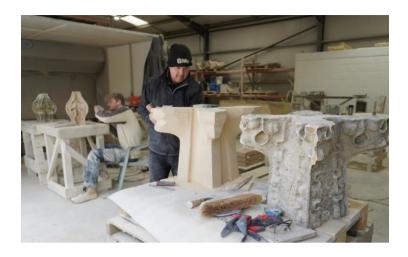
Wiltshire Stonemasons in action

Wiltshire Stonemasons of Broughton Gifford are now carving two new stones for us.

We are thrilled that Ewan a former Christ Church Primary and St Laurence Secondary School student and now a stone mason, has carved the top stone of our pinnacle for us, while Mark has carved the larger lower stone. It is clear from their complex and intricate carving that both very talented stone masons, and it is a joy to see these traditional skills in action.

Wiltshire Stonemasons will then reset and stabilise all the pinnacle stones back in place by the end of November 2023, the rest of the spire repairs will be completed, and the scaffolding can finally come down.
